FIG Services LLC d/b/a FOX INSPECTION GROUP  
Property Inspection Report #140923srgm-1614 Wakefield  
11227 Endicott Lane Houston, TX 77035

## PROPERTY INSPECTION REPORT

Concerning: 1614 Wakefield, Houston, TX 77018

By: Steven Reid, TREC# 7248, Grant Miller, AI# 20975 09/23/2014

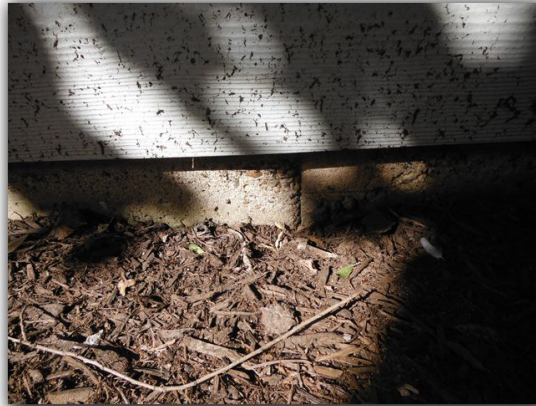
*Observed addition to original house foundation. "Cold joints" where the two slab abut each other is a location for wood destroying insect to enter house unseen.*

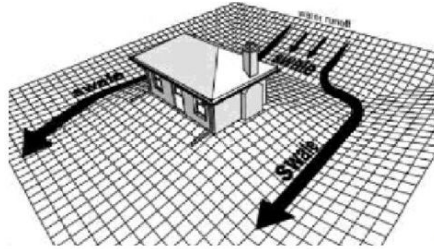
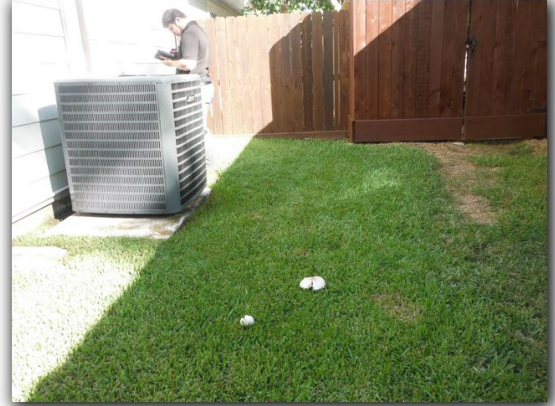
Drainage swale is not continuous at sides The drainage swale must be kept clear and continuously sloped in order to drain water properly.

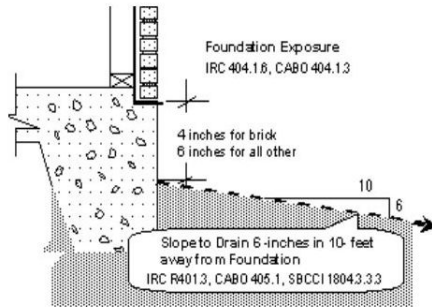
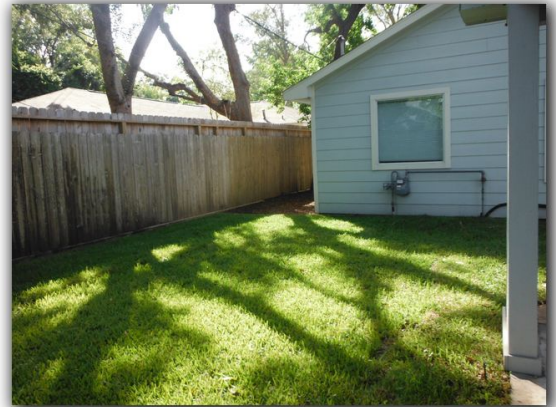
Soil grade and drainage patterns around some areas of house do not appear to properly direct water away from foundation to aid in controlling runoff water and could cause differential movement of the foundation or water penetration during heavy rains.

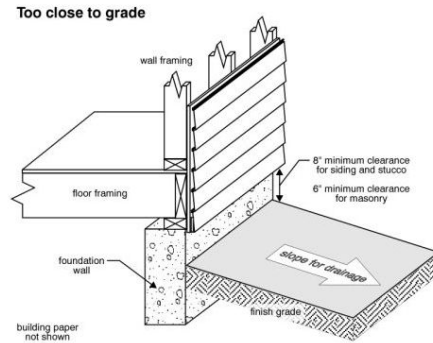
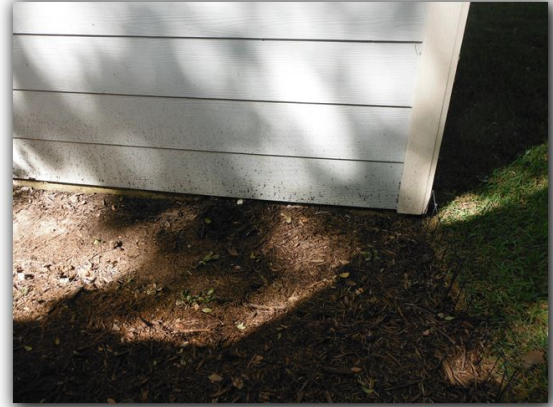
Soil level too high around areas with wood siding. Code and common industry practice requires a clearance of 6-8 inches from bottom of wood veneer to soil. High soil level near wood siding promotes water/termite penetration and wood rot.

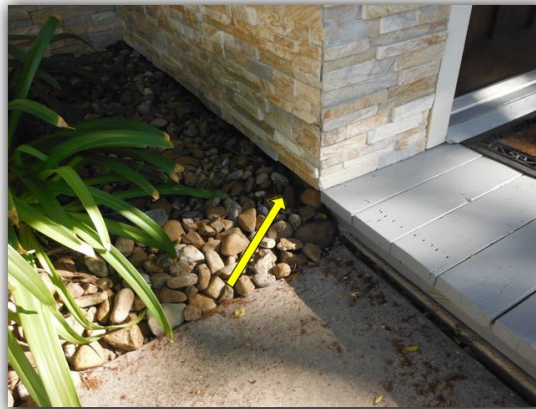
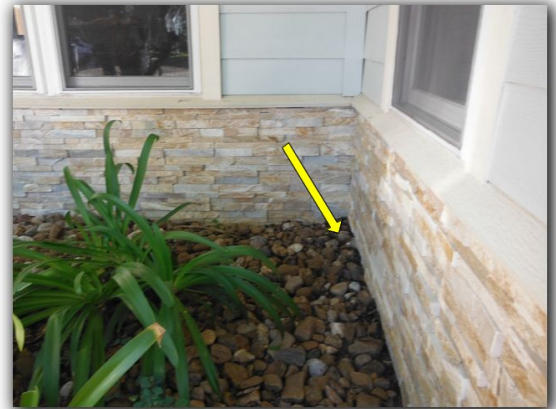
Soil level too high around areas with stone siding at front flower beds . Common industry practice requires a clearance of at least 4 inches from bottom of stone veneer to soil. High soil level near stone siding promotes wood rot and is considered a conducive condition to termite activity and water penetration.

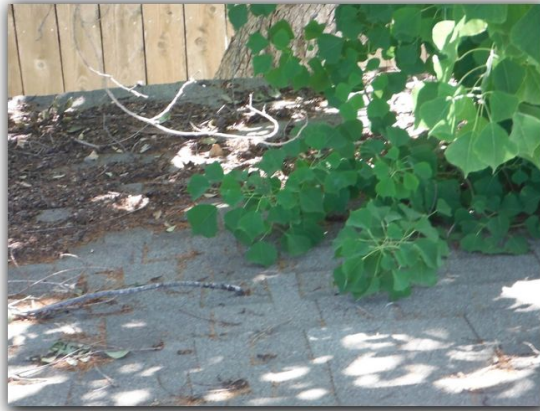
Tree limbs in contact with roof can/ will damage the roof.

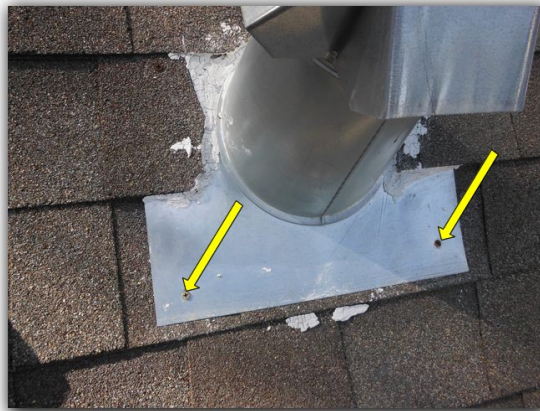
Exposed staples / nail heads / fasteners observed on roof are not properly sealed. Water entry possible.

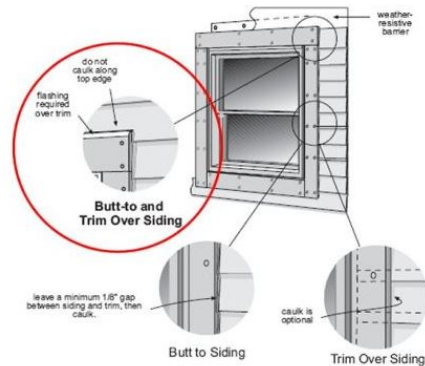
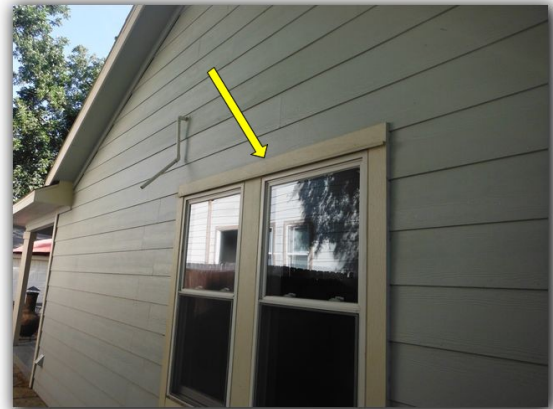
Head flashing missing over window/door trim pieces. Without head flashing over window trim, sealing must be maintained as a defense against water penetration.

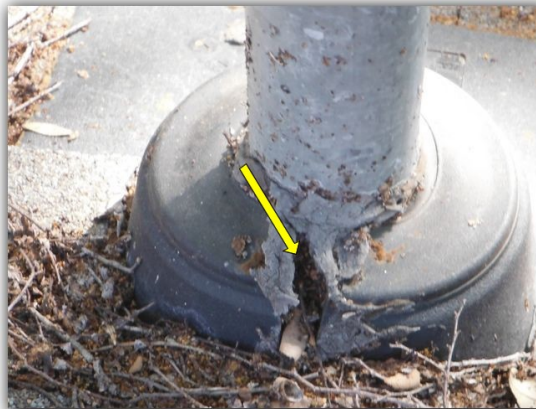
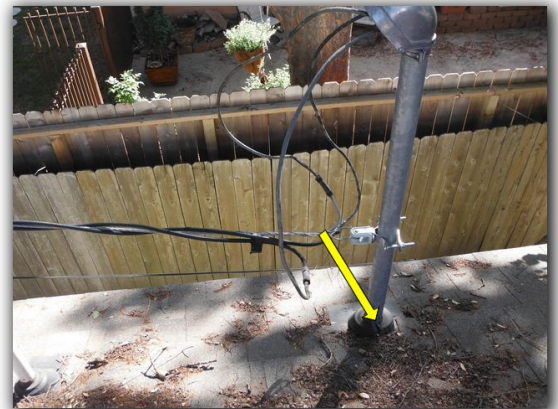
Rubber gasket of electrical drop has deteriorated, allows water entry.

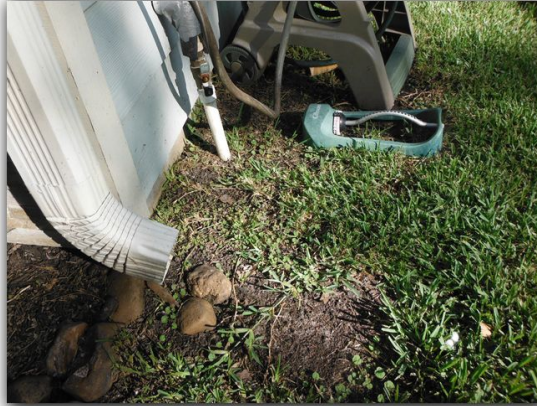
Downspouts need splash blocks at bottoms to prevent soil erosion.

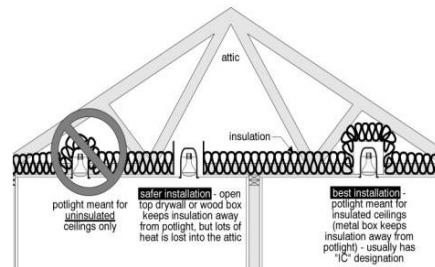
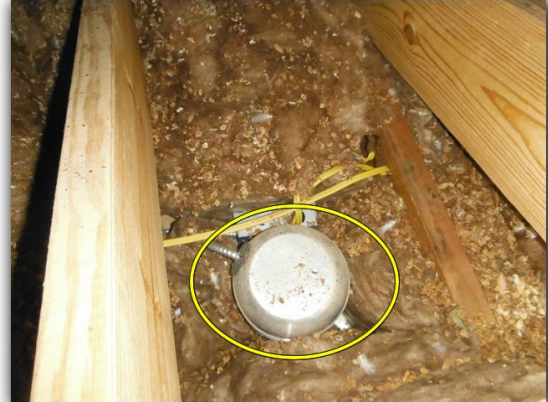
Potlights in insulated ceilings

Ensure insulation is maintained a minimum of 3 inches and wood a minimum of 1 inch from around all recessed lights to reduce possible fire hazard.

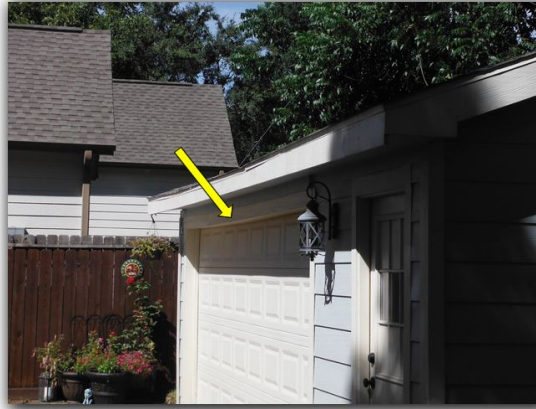
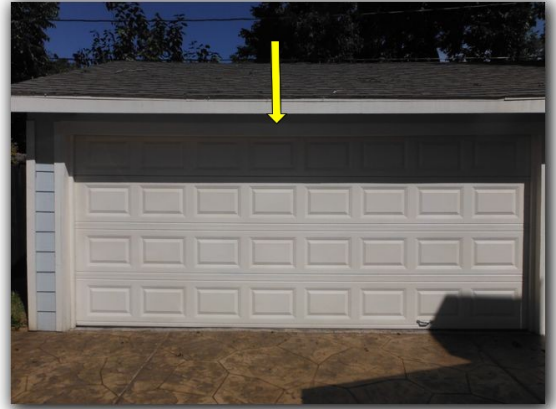
Sag in double header over garage door. Indication of improper/inadequate framing.

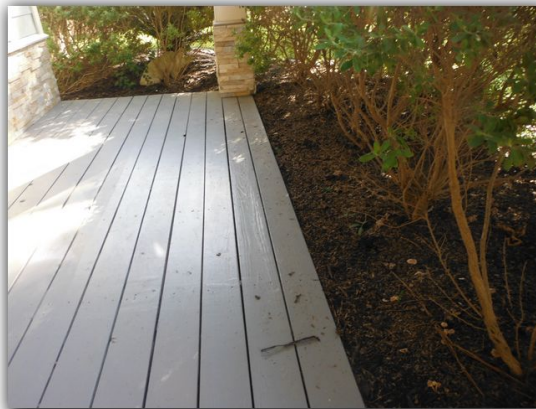
Earth wood contact in some areas, conducive condition to termite activity and wood rot.

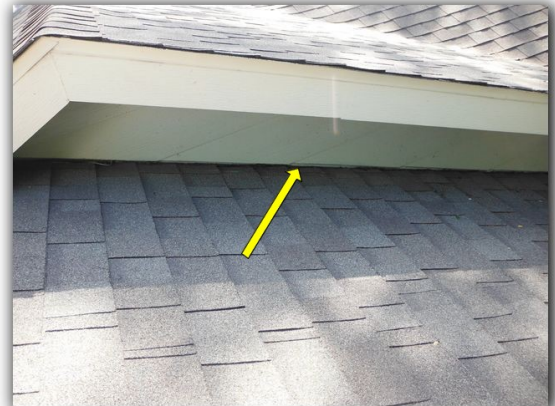
Exterior cement board siding installation does not comply with manufacturer's (James Hardie ) installation requirements which may/can/will void warranty. Installation requirements specifically state " Leave 2" clearance between roofing and bottom edge of siding.

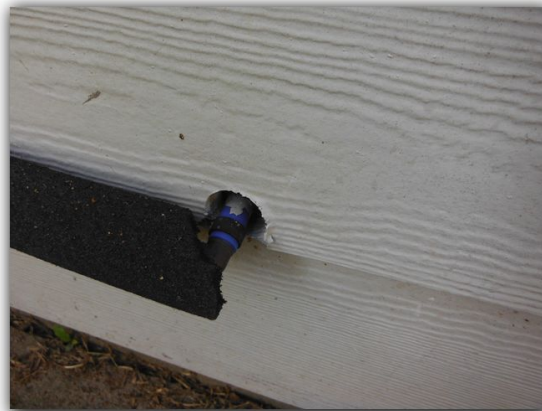
Need sealing / caulking around all holes and exterior siding penetrations on top and both sides, (leave bottom open) to prevent water entry. Including but not limited to dryer, bath and range top vents, light fixtures, etc.

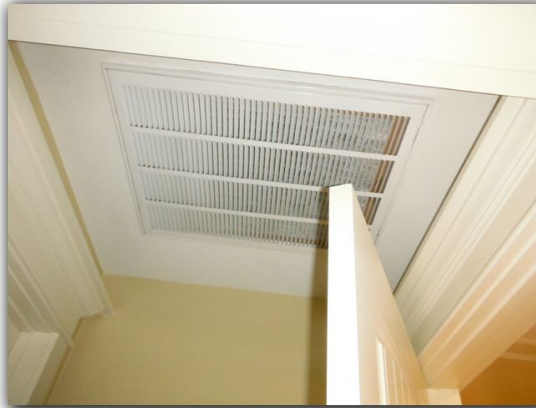
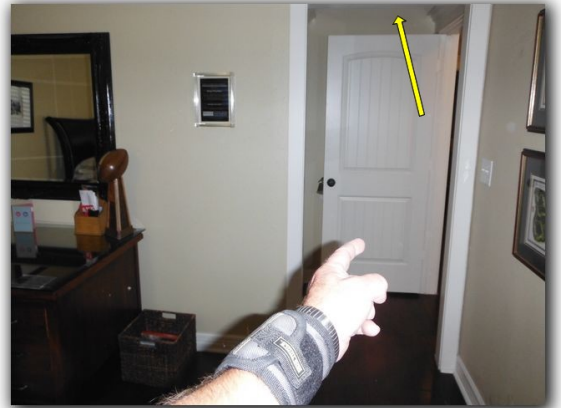
One or more doors in house are difficult to open / close due to improper air circulation when doors are closed.

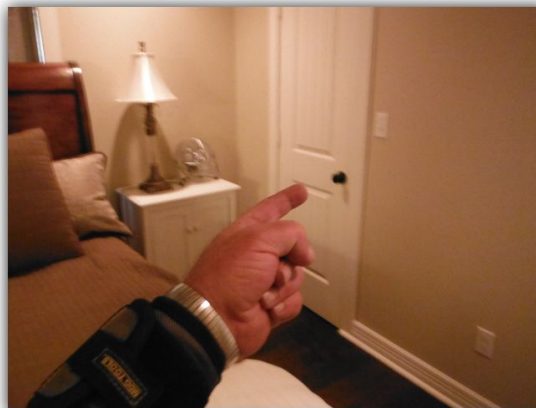
Door door is difficult to shut / close; Master bedroom closet.

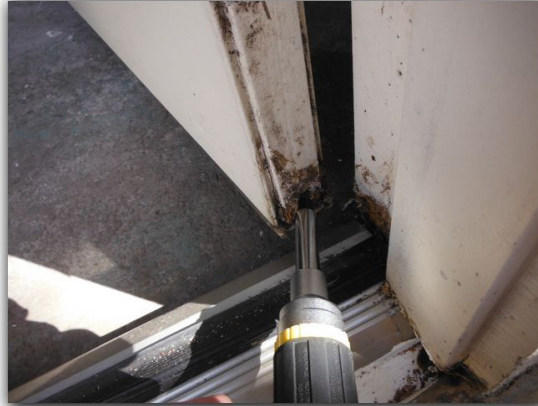
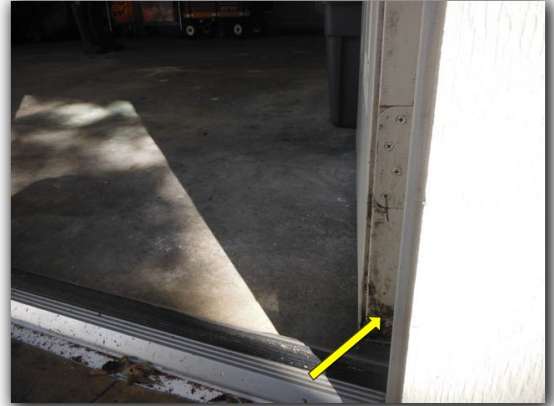
Wood rot of lower door and/or jamb; Garage pedestrian door.

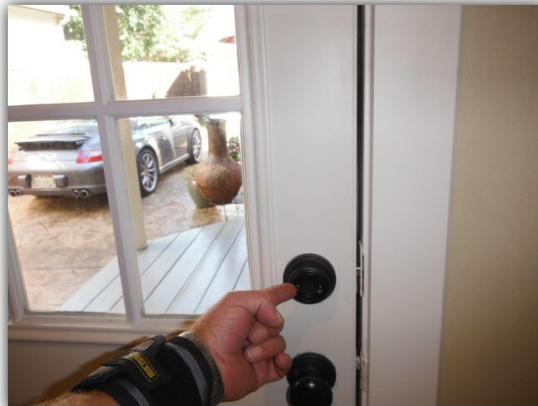
*Could not unlock back door off of Laundry room, no key.*

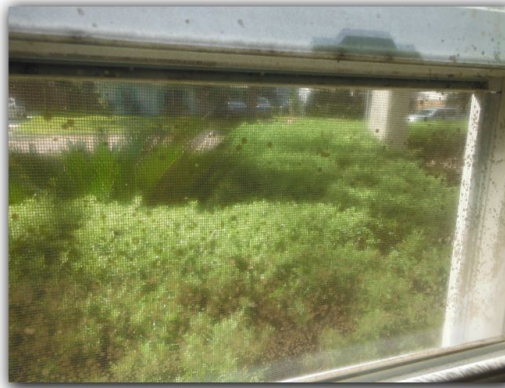
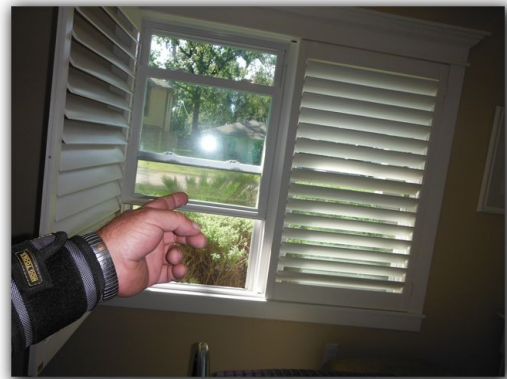
One or more of the thermal pane windows observed to have lost their seals. This has resulted in condensation and/or a fog like film to develop between the panes of glass. The thermal pane windows no longer function as designed when they loose their seals. The windows that have noticeably lost their seals are listed but may not be limited to the following: Southeast bedroom.

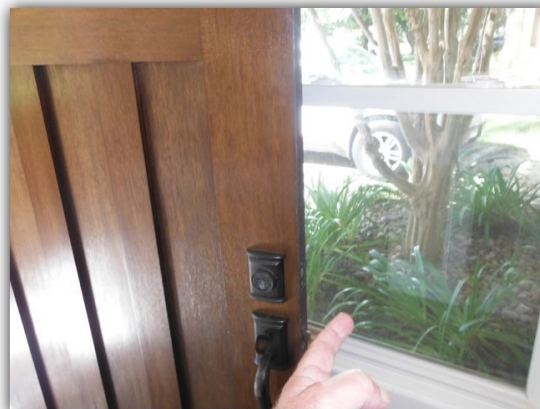
Could not find/observe markings on glass panel(s) of window(s) within 24" arc of closed door to indicate the presence of required tempered / safety glass which is a recognized safety hazard and code requirement. Ref CABO 308.4.6 UBC 2406.4.6 IRC R308.4.6.

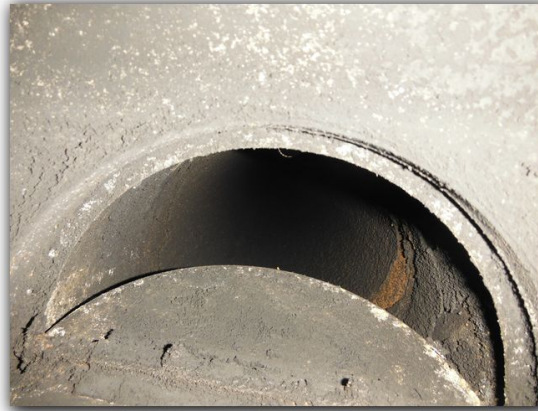
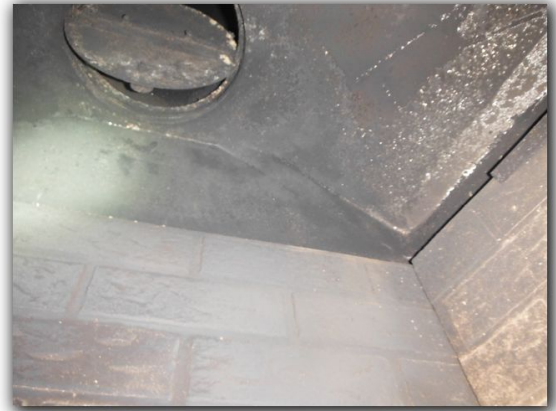
Soot build up in fire box and/or flue, should be cleaned by a qualified chimney sweep.

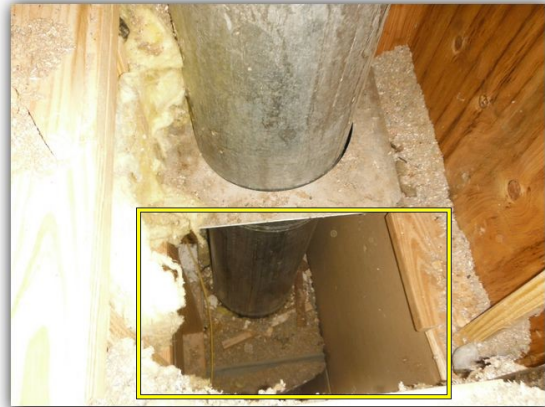
Chimney is not properly fire stopped in attic ; Does not comply with the 1992 CABO One and Two Family Dwelling Code section R-402.7 IRC R1001.16.

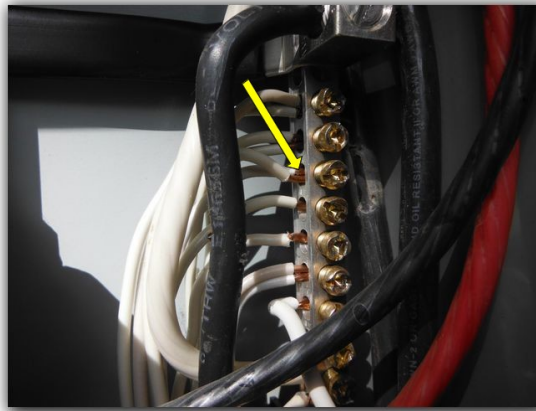
Observed two or more neutral conductors under one screw lug on the neutral bus.  
Current industry standards and National Electric Code permit one neutral conductor  
per screw lug.

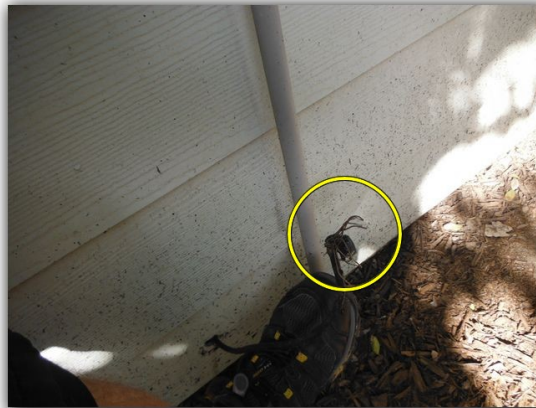
Ground clamp and/or wire not secured to ground rod below service meter.

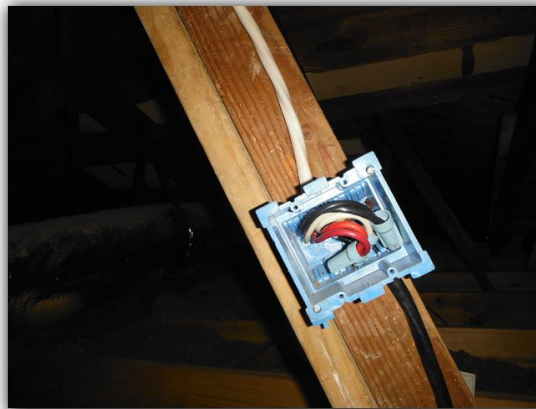
Wire improperly terminated, including but not limited to the following location: Attic.

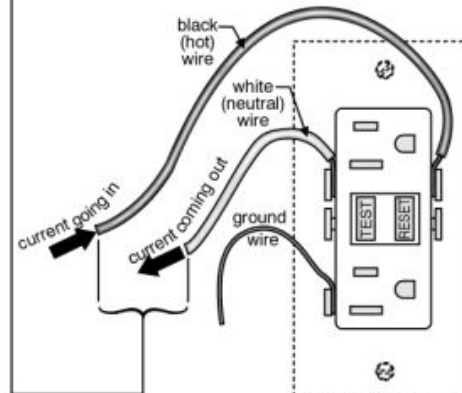
Did not observe GFCI protection of all outlets in required locations, including but not limited to the location marked below. This condition is a recognized safety hazard and is in need of repair.

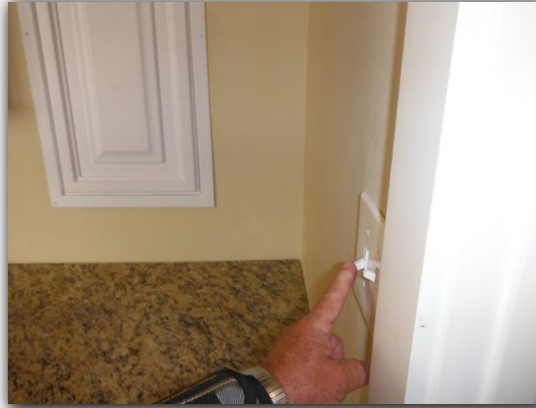
*Unknown control, mystery switch(s) found, recommend inquiring current resident regarding use/control.*

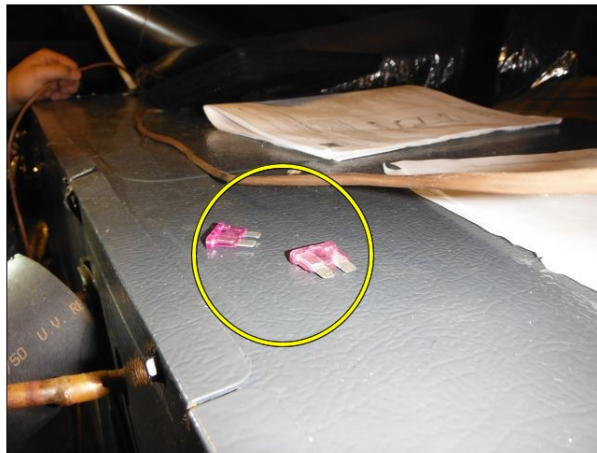
*Observed blown fuses at furnace. Recommend client consult with seller regarding possible service issues with the unit.*

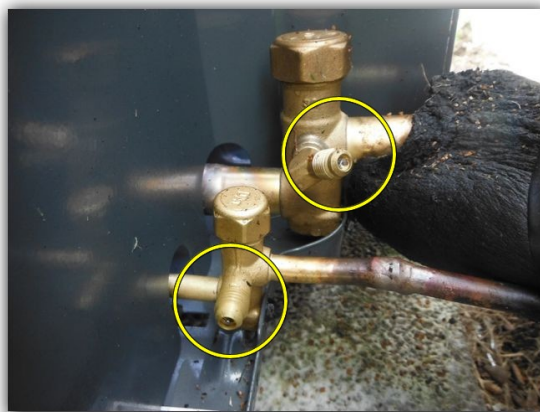
Missing cap on Freon line(s) valves at unit.

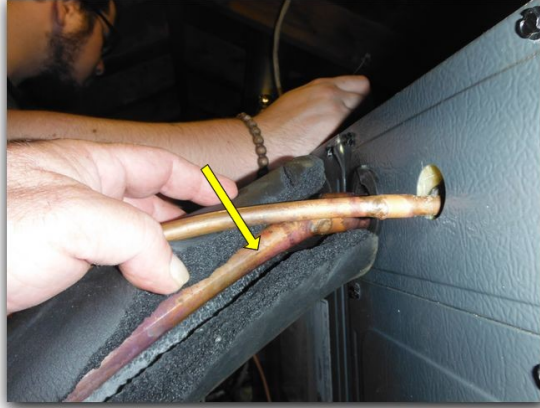
Section(s) of suction line insulation missing in attic near coil. Warm attic air condenses on cold suction line/expansion valve and drips condensation.

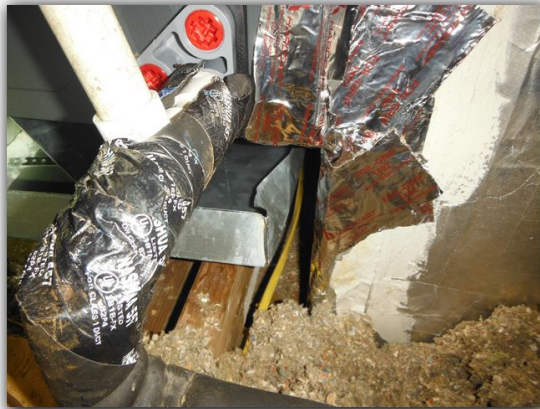
Secondary drain pan contains water, correct existing condition.

Drain pan not properly positioned and/or secure below evaporator coil, if coil leaks it may/will leak onto ceiling below.

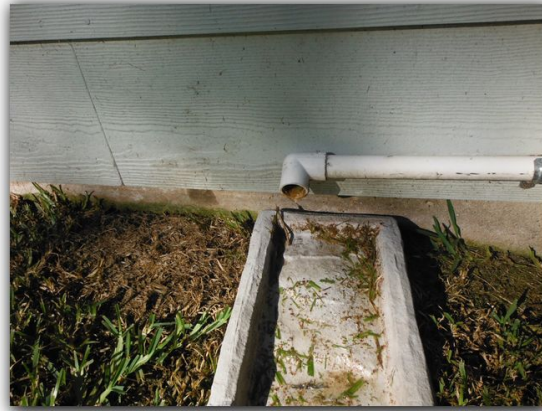
Primary drain line should not be allowed to discharge water right next to foundation.

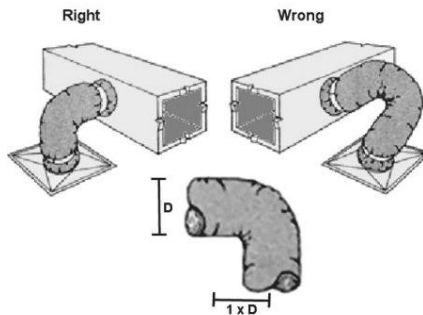
Some flex duct observed to be improperly routed with sharp bends and / or excess material in bends. Improper routing increases frictional loss in the duct and reduces heating and cooling efficiency. Radius at centerline of the bend should be no less than the diameter of the duct.

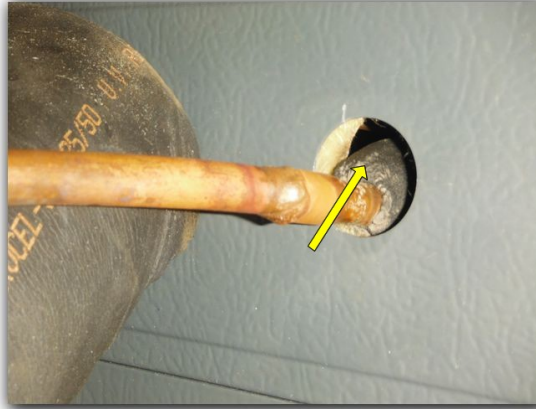
Excessive air loss at evaporator coil around drain and Freon line connections.

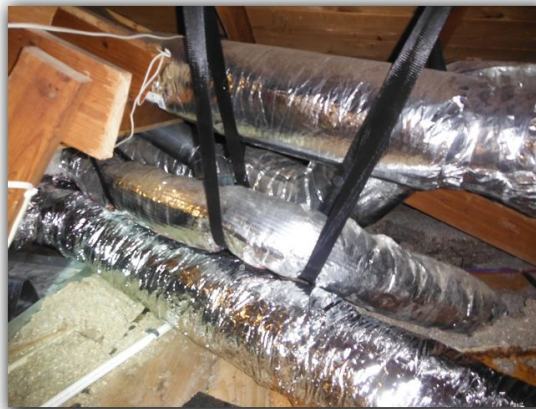
Observed several / multiple areas in attic where flex duct touch and are missing required 1" clearance from other ducts to prevent condensation between ducts that touch. Recommend general maintenance to flex ducts in attic. Re-support where needed, seal/tape minor air leaks, repair torn/damaged vapor seal, etc.

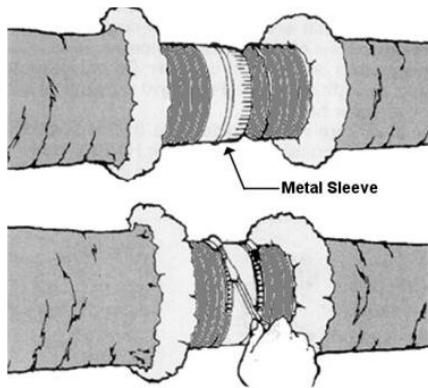
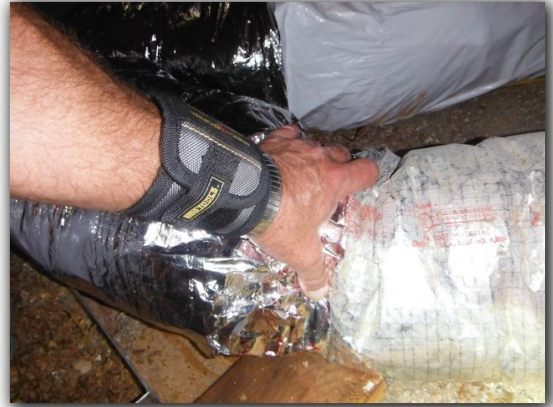
Observed one or more areas of improper splicing of flex duct. Missing required metal collar / coupler as required by manufacturer and installation instructions included inside every box and/or on exterior of every bag of flex duct.

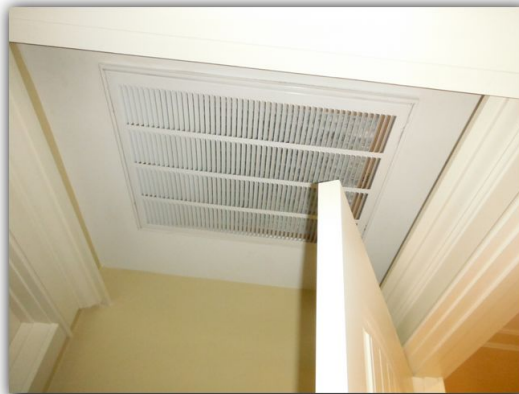
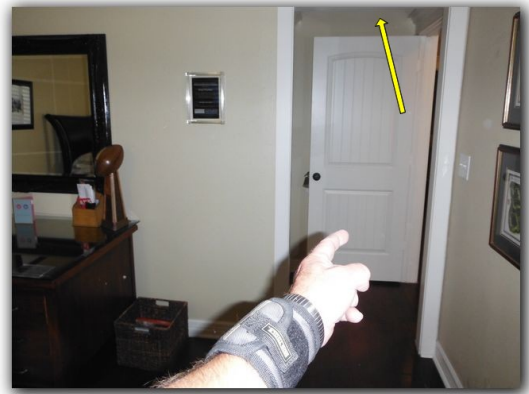
Return air is improperly located in a bedroom. When the bedroom door is closed air will not circulate through the house properly.

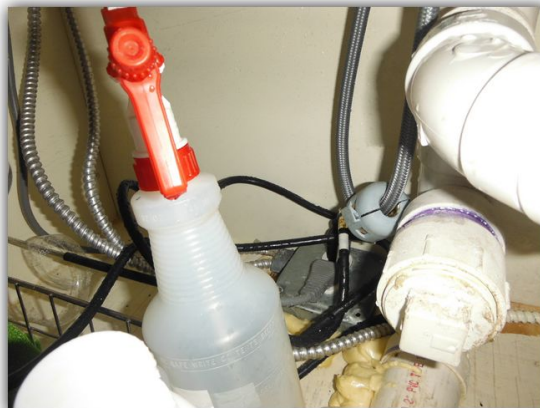
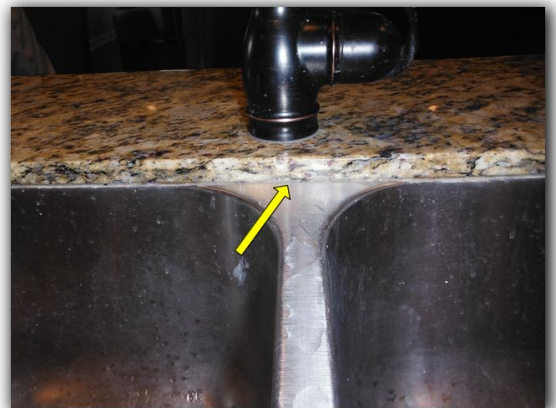
Small leak below sink, Kitchen.

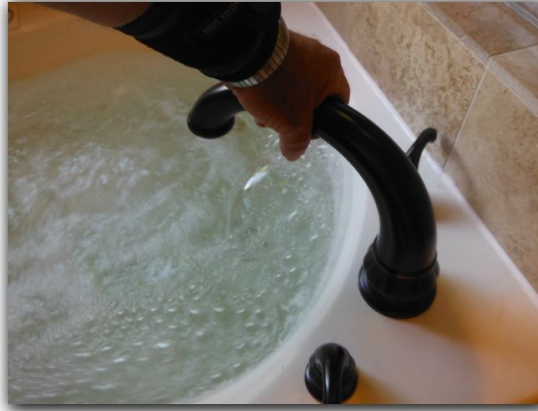
Faucet loose, not secured; Master bathroom tub.

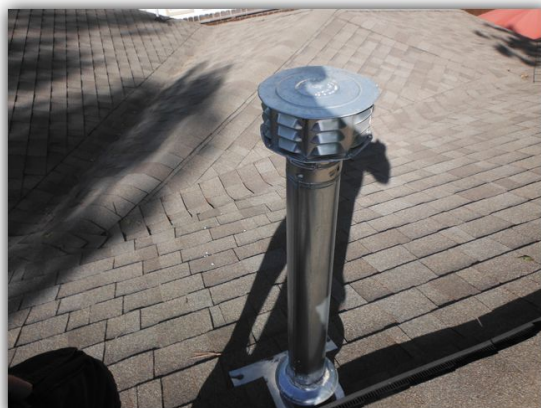
**Observed gas smell on roof near water heater vent, did not smell gas in attic.**

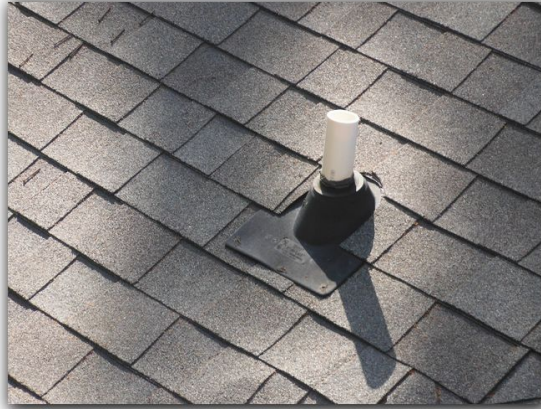
Painting of exterior plastic PVC vents above roof line required to prevent UV damage.

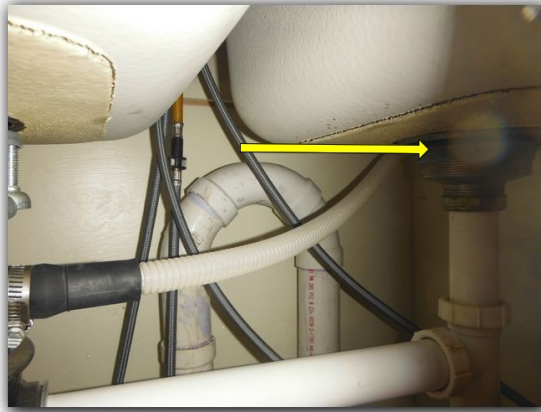
Kitchen sink island vent was not observed to be higher than the sink drain opening.

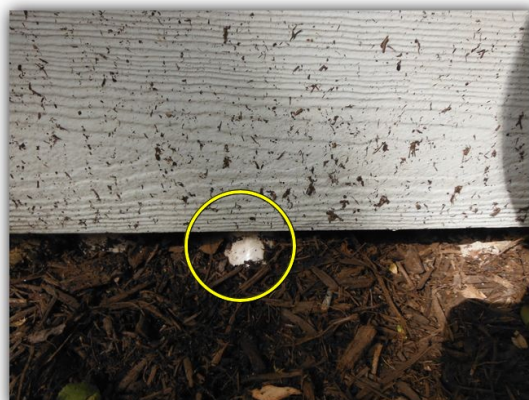
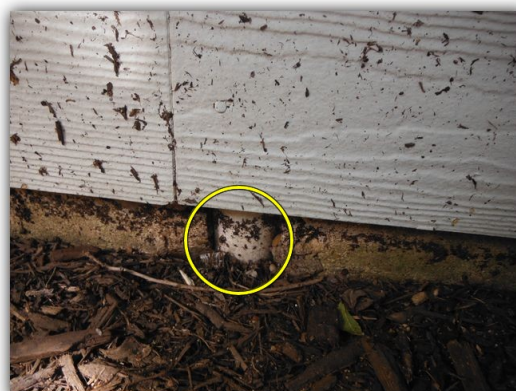
Observed exposed PVC drain lines at edge of foundation.

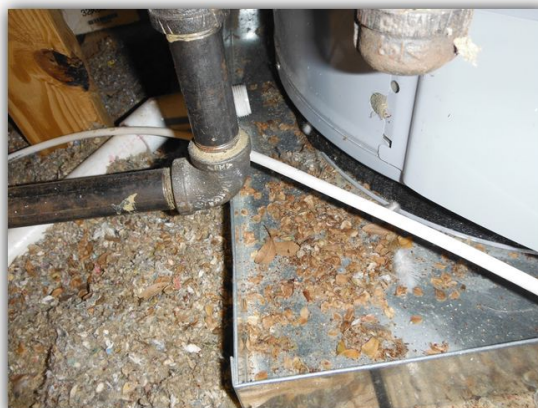
Insulation / debris in drain pan needs to be removed to prevent clogging of drain line.

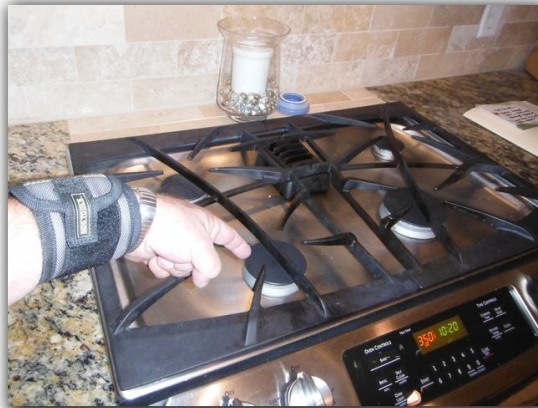
Gas spark igniter is not fully operational, would not ignite front left burner.

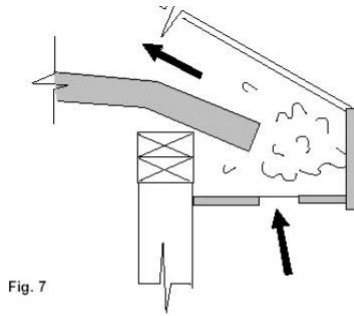
Improperly vents to soffit. Should vent to exterior.

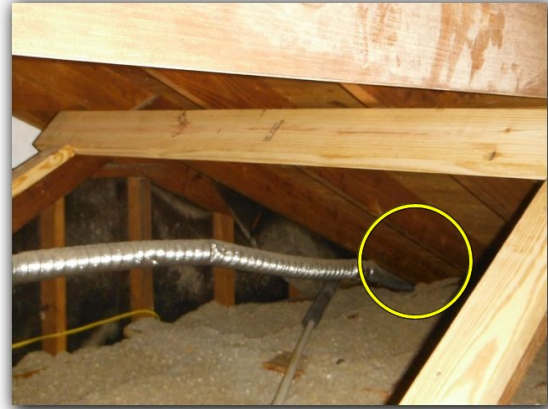
Terminating exhaust fans to soffits/eaves builds up condensation moisture within the soffit that can deteriorate the fascia board, soffit and/or plywood roof decking and cause paint peeling. A soffit/eave is part of attic air space where exterior air is drafted in to the attic space with the exhaust duct fumes and moisture.

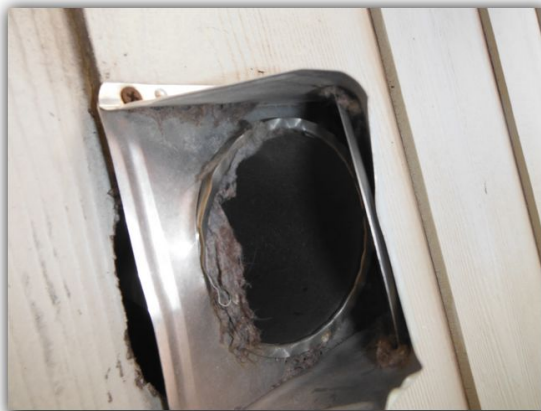
Exterior dryer flapper door stuck open (remove lint) and/or damaged.
